TRUCK UTILITY LT GS SERIES 3 LANDROVER, ALL TYPES
PINTLE HOOK LOCKING LATCH
MODIFICATION INSTRUCTION

Introduction

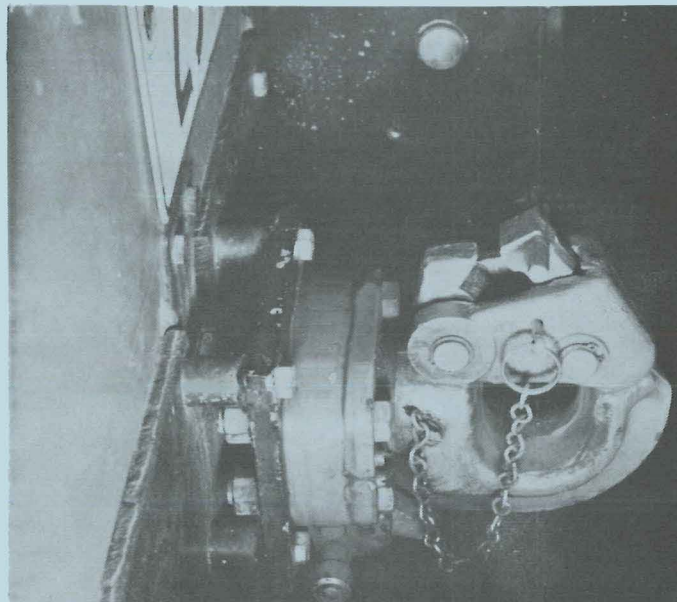
1. This instruction details the reworking of the pintle hook locking latch to prevent the locating cotter pin being inserted on the under side of the locking latch. Figure 1 shows this defect.

FIG 1 - LOCATING COTTER PIN INCORRECTLY POSITIONED
HOLDING THE LOCKING LATCH FULLY DISENGAGED

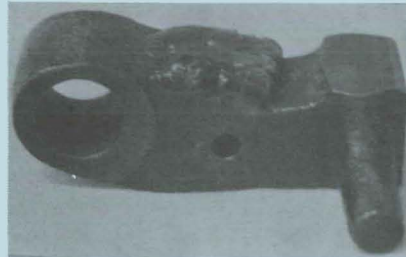
FIG 2 - WELD BUILD-UP ON LOCKING LATCH

7. To carry out the modification proceed as follows:
 - a. Remove the locking latch from the pintle hook.
 - b. Using a suitable mild steel electric welding rod, build up the locking latch area directly below the locating cotter pin hole to a height of 5 mm, as shown in Fig 2. Ensure the built up area extends the full width of the locking latch.
 - c. Dress up the weld area as shown in Fig 3, do not remove more than 1 mm of weld height.
 - d. Paint the reworked area in accordance with WKSP B 700.
 - e. Refit the locking latch to the pintle hook. Ensure that the locating cotter pin cannot be inserted on the wrong side of the latch.

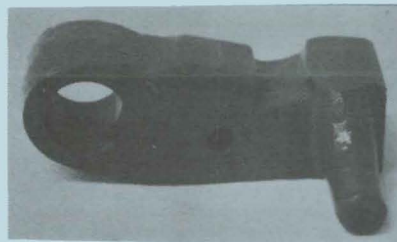
FIG 3 - COMPLETED MODIFICATION
