TRUCK, UTILITY, LIGHTWEIGHT, MC2 -- LANDROVER, SERIES 3, ALL TYPES
WATERPUMP/THERMOSTAT BY PASS TUBE PACKING SEAL
MISCELLANEOUS INSTRUCTION

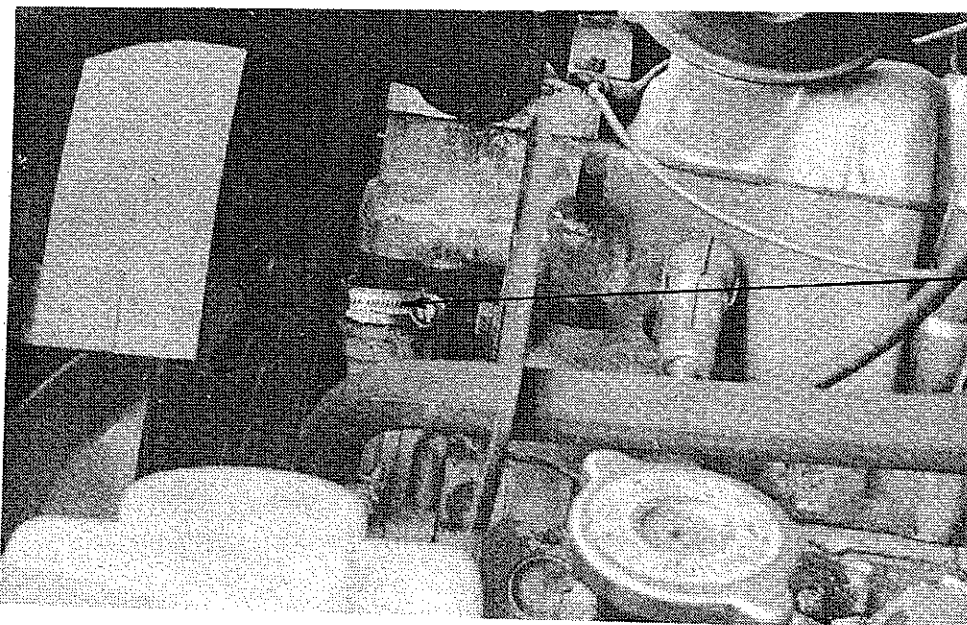
FIG 1 -- HOSE CLIP IN POSITION

1. Instances have been reported of failure of the packing seal fitted to the water pump/thermostat by pass tube. This instruction details an interim repair method that can be carried out in the field to enable a vehicle with a water leak, at this packing seal, to return under its own power to the first available repair facility.

2. To carry out the interim repair refer to Fig 1 and proceed as follows:
 - a. Drain the coolant to a level just below the packing seal leak.
 - b. Thoroughly wipe clean around the sealing area.
 - c. Apply a liberal amount of Silastic Compound DSN 8040-00-728-3088 completely around the packing seal.
 - d. Fit Hose Clamp, 22 mm to 38 mm Size range, (Utilux No 1) DSN 4730-66-012-8260 around the silastic and packing seal.
 - e. When the silastic is dry top up the cooling system.
3. In addition to an interim repair, the above procedure is recommended whenever a new packing seal is fitted. The silastic will reduce deterioration of the seal and the hose clip will prevent water pressure from forcing its way past the seal.
